Effects of Different Fuel Specifications and Operation Conditions on the Performance of Coated and Uncoated Superheater Tubes in Two Different Biomass-Fired Boilers

Published in:
Applied Energy Materials

Publication date:
2018

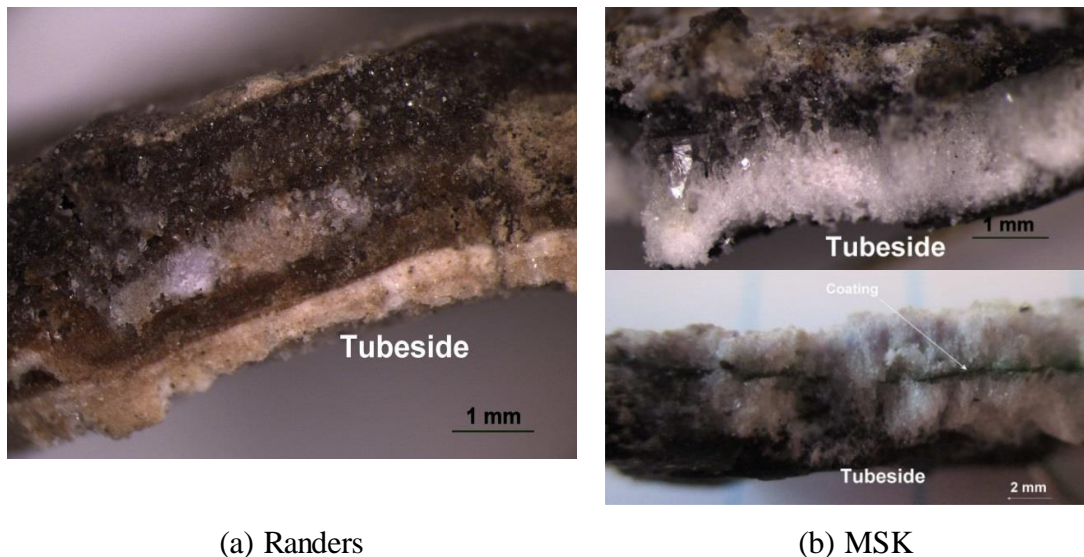
The deposits were removed from the exposed tubes and examined with SEM-EDX. The deposit from Randers was sintered to the tube and a scalpel was required for removal whilst the deposit from MSK was fragile and easily flaked off. Photographs of the deposits are shown in Figure 11. The deposit from Randers was more compact with different layers where a whitish layer was present adjacent the tube. When the deposit was removed from the tube, almost no oxide was adherent. The deposit from MSK consisted of white crystals adherent to the underlying oxide and on the coated tube. Some of the coating was also present within the deposit. Analysis of this spalled coating is described in our previous work.²⁸

Figure 11. Appearance of deposit removed from the exposed tubes (a) deposit from Randers power plant, (b) deposit from MSK power plant.

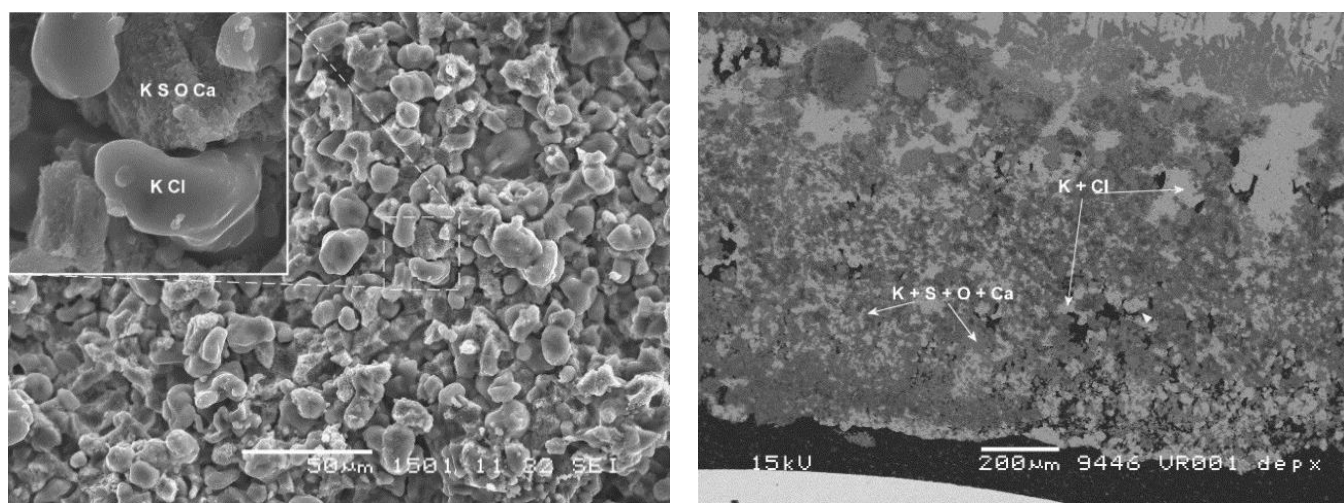
The surface morphology and composition of the deposit close to the tube was investigated using SEM-EDX on both deposit flakes and cross-sectioned deposits. For deposit from Randers, the analysis of the underside of the deposit revealed two different morphologies (Figure 12a), a smooth morphology, which was probably KCl as the measured mole ratio for K/Cl was 1:1, and small particles that were presumably sulphates of potassium and calcium. Analysis of the dry polished cross-sections of the deposit also detected K, S, Ca and O and K, Cl rich regions (Figure 12b). These elements were present throughout the deposit, however there were more Si rich particles on the outer part of the deposit.

Figure 12. SE micrograph of surface morphology and BSE micrograph showing the composition of deposit from Randers (a) deposit adjacent to tube, (b) Cross-section of deposit.

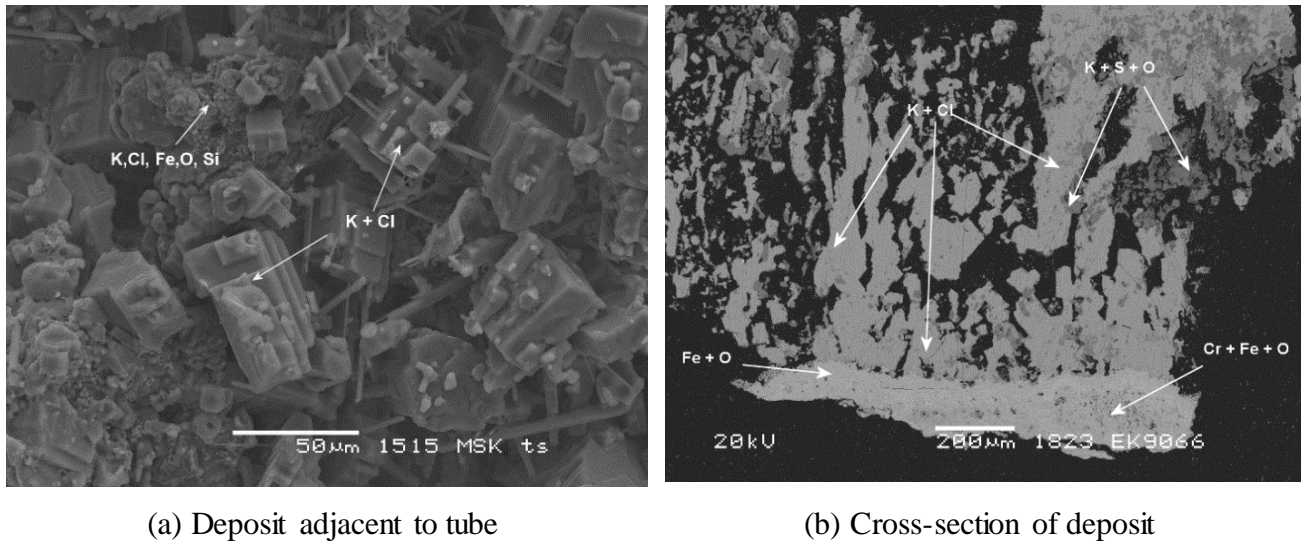
Facetted cubic structures were typical on the unprepared deposit from MSK (Figure 13a), where the cubic structures had a composition corresponding to KCl. The KCl was in direct contact with the surface oxide and there were remnants of iron oxides on the surface. Cross sections of the dry polished deposit also showed that KCl is present adjacent to the oxide surface and there was only occasionally K, S, and O (presumably potassium sulphate) present (Figure 13b).

Figure 13. SE micrograph of surface morphology and BSE micrograph showing the composition of deposit from MSK (a) deposit adjacent to tube, (b) Cross-section of deposit.

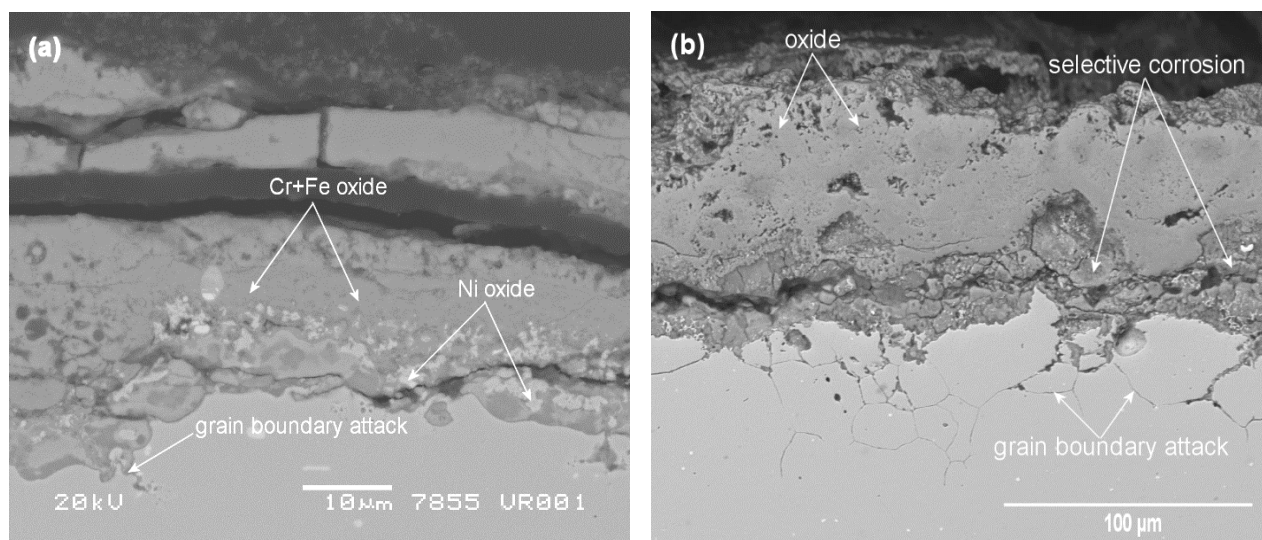
The corrosion morphology of the exposed uncoated tubes from Randers (Esshete 1250) and MSK (TP347H) are similar. The corrosion morphologies consist of a porous outer oxide, an inner selective corrosion area and grain boundary attack (Figure 14). The oxide located in the outermost corrosion product was rich in chromium and iron, while the oxide beneath was rich in nickel. No indications of formation of a protective chromium-rich oxide could be seen. This type of corrosion morphology is typical for chlorine induced corrosion, where volatile metal chlorides form via reaction of metal with chlorine species. As metal chlorides are transported towards the outer surface they react with oxygen to form the porous outer oxide while the chlorine is released to again react and form new volatile metal chlorides, a chlorine corrosion cycle that is often referred to as active oxidation.² Because of the progression of the corrosion attack it is unclear if an initial breakdown of protective oxide scale occurred due to potassium chromate formation from a chemical reaction

between chromium rich oxide and KCl as shown in laboratory studies or whether corrosive chlorine species could enter into the steel/oxide interface along pores or cracks in the oxide.^{16,30,31}

Figure 14. Corrosion morphology on uncoated tubes after boiler exposure in (a) Randers and (b) MSK.

After exposure, the actual metal loss for the non-coated steel was measured for both plants. The corrosion rate was then calculated based on the measured metal loss and the total exposure time (Table 4), which clearly reveals that the corrosion in the MSK plant is much more aggressive than at Randers. For the exposure in MSK, the average metal loss and corrosion rate are almost 30 times higher than Randers.

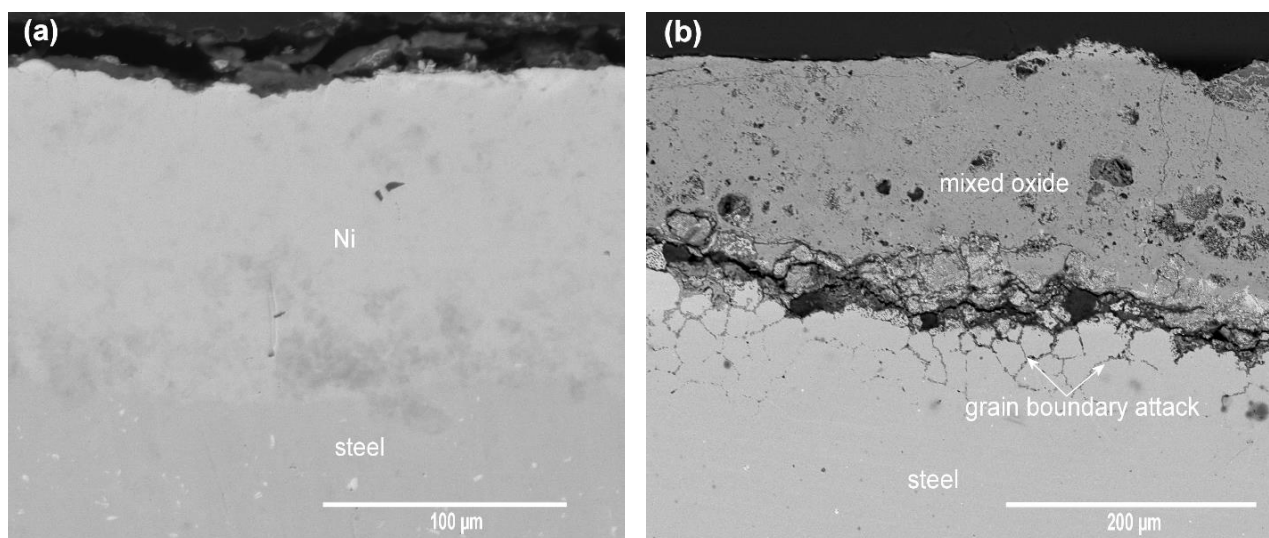
The corrosion morphology of the exposed Ni coated tubes for Randers and MSK are very different as shown in Figure 15. The Ni coated tube showed good performance after exposure in Randers where the Ni layer was still attached to the steel and no significant attack was measured. The measured metal loss is $3.37(\pm 2.25)$ μm and the calculated corrosion rate for Ni is 0.47 $\mu\text{m}/1000\text{h}$. Similar results have been observed in the laboratory. Ni revealed a significantly better performance compared to Fe-Cr-Al alloys at 670°C with KCl in air, but had lower performance compared to NiAl alloys.¹⁸ When two different exposures were conducted at 600°C with slightly different oxidising gases and with and without KCl, a nickel oxide of 4 μm was formed in both exposures even though the amount of KCl was much higher in one of the experiments.¹⁶ However, for the exposure in MSK, severe attack occurred and the $135\mu\text{m}$ thick Ni layer was no longer present. The corroded tube section had a mixed iron and chromium oxide at the surface and grain boundary attack into the substrate steel, which was similar to the corrosion morphology observed on the uncoated tube. It is highly probable that the slight mismatch in thermal expansion coefficients gives problems where there is excessive thermal cycling at MSK. Thus cracks/channels can form that allow for the migration of corrosive species to the Ni-steel interface and the outward migration of Cr chlorides.²⁸ The corrosion attack thus occurring underneath the Ni-layer will further contribute to poor adhesion between Ni-layer and steel tube.

Figure 15. Corrosion morphology on Ni coated tubes after boiler exposure in (a) Randers and (b) MSK

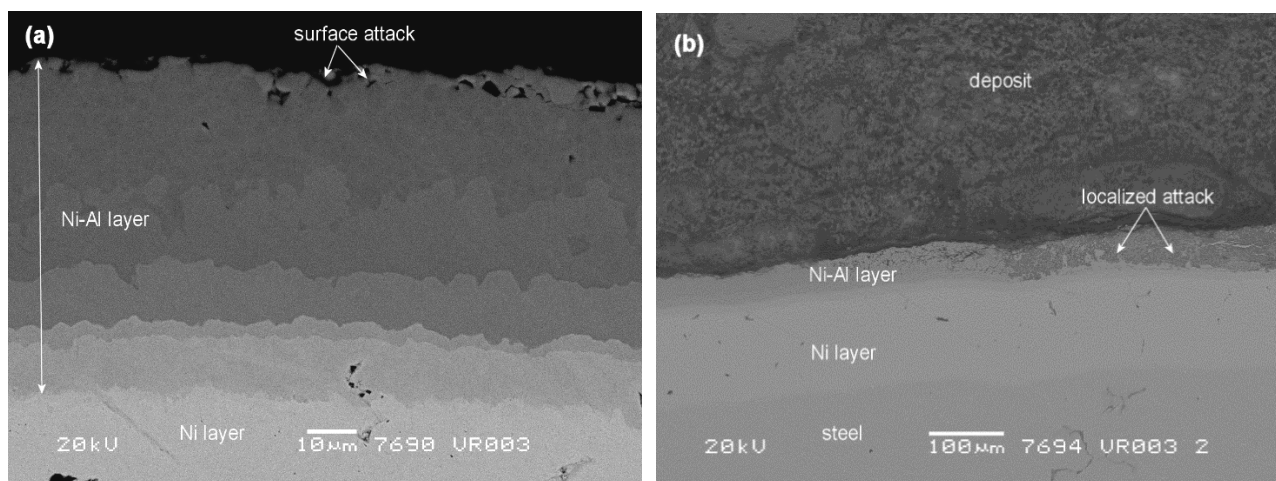
The Ni_2Al_3 coated tube showed good high temperature corrosion performance after testing in the Randers boiler. In most places (4/5 of the observation area), the Ni_2Al_3 coating showed protective behaviour with only slight surface attack (Figure 16a). In localized areas (1/5 of the observation area), the Ni_2Al_3 coating was attacked and Al depletion was visible. However, the coating attack ended above the Ni layer and no further penetration was observed (Figure 16b). At all locations, the underlying steel was well protected without sign of corrosion attack. Compared to the as-coated condition shown in Figure 10, some interdiffusion between the Ni_2Al_3 layer and the Ni layer is observed, resulting in formation of other phases from the Ni-Al phase diagram at the interface.

Figure 16. Corrosion morphology on Ni_2Al_3 coated tube after boiler exposure in Randers.
(a) general protective area, (b) localized attack area.

Compared with Ni, Fe and Cr, Al has the highest affinity for reaction with both chlorine and oxygen. Presumably, aluminium chloride can form at the deposit/ Ni_2Al_3 coating interface when the oxide partial pressure is low. Because of the low melting point of aluminium chloride (192 °C), aluminium chloride will volatilize and migrate outwards rapidly.¹⁸ The volatilized aluminium chloride will be transformed into aluminium oxide where the oxygen partial pressure is higher, leaving behind a depleted or porous area. Li et al. saw rapid early stage volatilization when exposing Fe-Al alloys and a NiAl alloy to NaCl-KCl melts at 670 °C but observed that the attack slowed down when a thicker alumina layer was established on the surface.¹⁸ This agrees well with the corrosion morphology observed on the Ni_2Al_3 coated tube in Figure 16a. The surface attack of the Ni_2Al_3 coating indicates that an initial corrosion attack has happened, while a continued attack did not occur. However, in some locations (localized attack in Figure 16b), there was no slowing down when attack was initiated. Some studies have argued that this type of attack can be due to a chemical reaction between alumina and gaseous KCl where the flue gas temperature is high, which can break down the protective alumina.¹⁹ According to the investigations by Pettersson et al.,³⁵ gradual volatilization of KCl would occur at temperatures above 560°C, where the vapour pressure of KCl exceeds 10^{-6} atm. With the breakdown of the protective Al_2O_3 , the corrosion process could proceed and a porous Al-depleted layer would develop underneath the surface (Figure 16b).

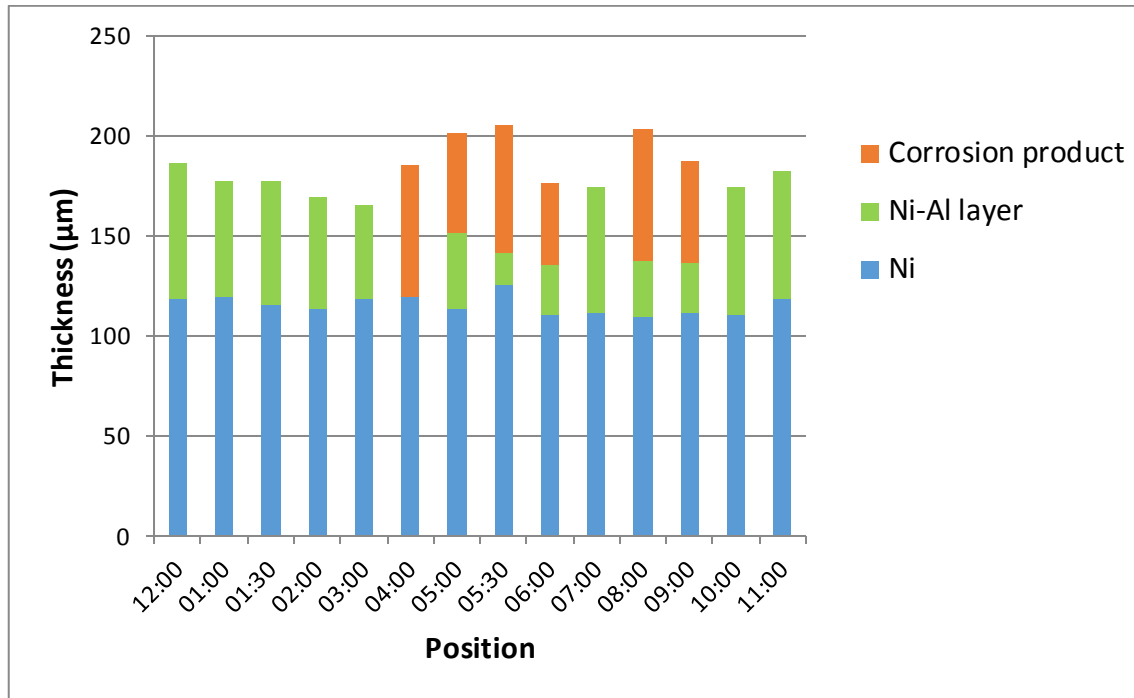
The coating thickness was measured after exposure in 12 positions clockwise around the circumference of the Ni_2Al_3 coated tube as shown in Figure 17 where 12:00 is the flue gas direction. The coating thickness around the Ni_2Al_3 coated tube is asymmetric. The deposit growth is typically asymmetric around a superheater tube depending on the flue gas flow conditions that vary around the tube. The attack at areas opposite the flue gas may be due to the varying deposit parameters on the upstream (12:00) compared with the downstream (06:00) part of the tube.³⁴

Figure 17. Residual thickness of layers around the circumference of the Ni_2Al_3 coated tube in Randers.

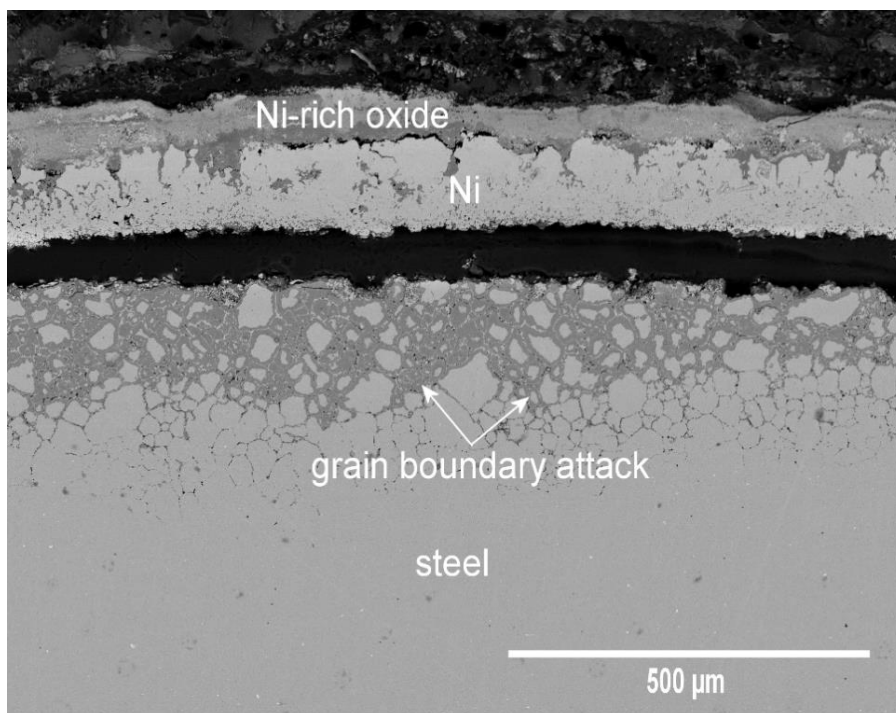
Compared with the exposure in Randers, the Ni_2Al_3 coated tube performed much worse in MSK. As shown in Figure 18, the nickel aluminide layer was no longer adherent to the tube; this was the case around the whole tube circumference. The spalled nickel aluminide coating could be found within the deposit, and investigations showed that in the spalled section some Al depletion had occurred but there was still alumina. This was documented in detail in previous work.²⁸ Remnants of an oxidized nickel layer (up to 70 μm) were present in approximately two-thirds of the circumference of the tube sample with varying depths of attack of the underlying tube. This indicates that the Ni_2Al_3 layer offered some initial protection before spalling off, since there was no Ni left on the tube coated only with Ni (cf. Fig. 15b). The previous investigation showed that the presence of a Ni_2Al_3 coating hinders evaporation of metal chlorides from the corrosion front, but does not prevent Cl species diffusing to the corrosion front. Beneath the Ni layer, the formation of trapped nickel chloride also hampered the corrosion process by binding the aggressive chlorine.²⁸

Figure 18. BSE image of corrosion morphology for the Ni_2Al_3 coated tube after boiler exposure in MSK

Since there are many thermal cycles at MSK (Figures 3 and 4), the most probable explanation for the spallation of the Ni_2Al_3 coating lies in the difference in thermal expansion coefficients between the steel, Ni, Ni-Al intermetallics forming at the interface and the Ni_2Al_3 . The coefficients of thermal expansion (CTE) for the steels, Ni, NiAl and Ni_2Al_3 are depicted in Figure 19. For the
